The Mayville Community Centre is an innovative and model project not only greatly improving the original building but demonstrating how this common building typology, a medium sized Victorian solid masonry building, can be transformed to achieve energy consumption reductions to exceed current UK building regulation standards, the lesser Passivhaus Enerphit standard and even the UK's 2019 targets for non-domestic buildings, demonstrating how refurbishment rather than demolition is a viable and replicable solution.

Project Overview

Name: Mayville Community Centre
 Location: North London
 Building Type: Community Centre
 Construction type: Deep retrofit with external insulation.
 Completed in: July 2011
 Occupancy status: Occupied as of July 2011
 Construction Cost: £1979/sqm, including prelims, overhead & profit

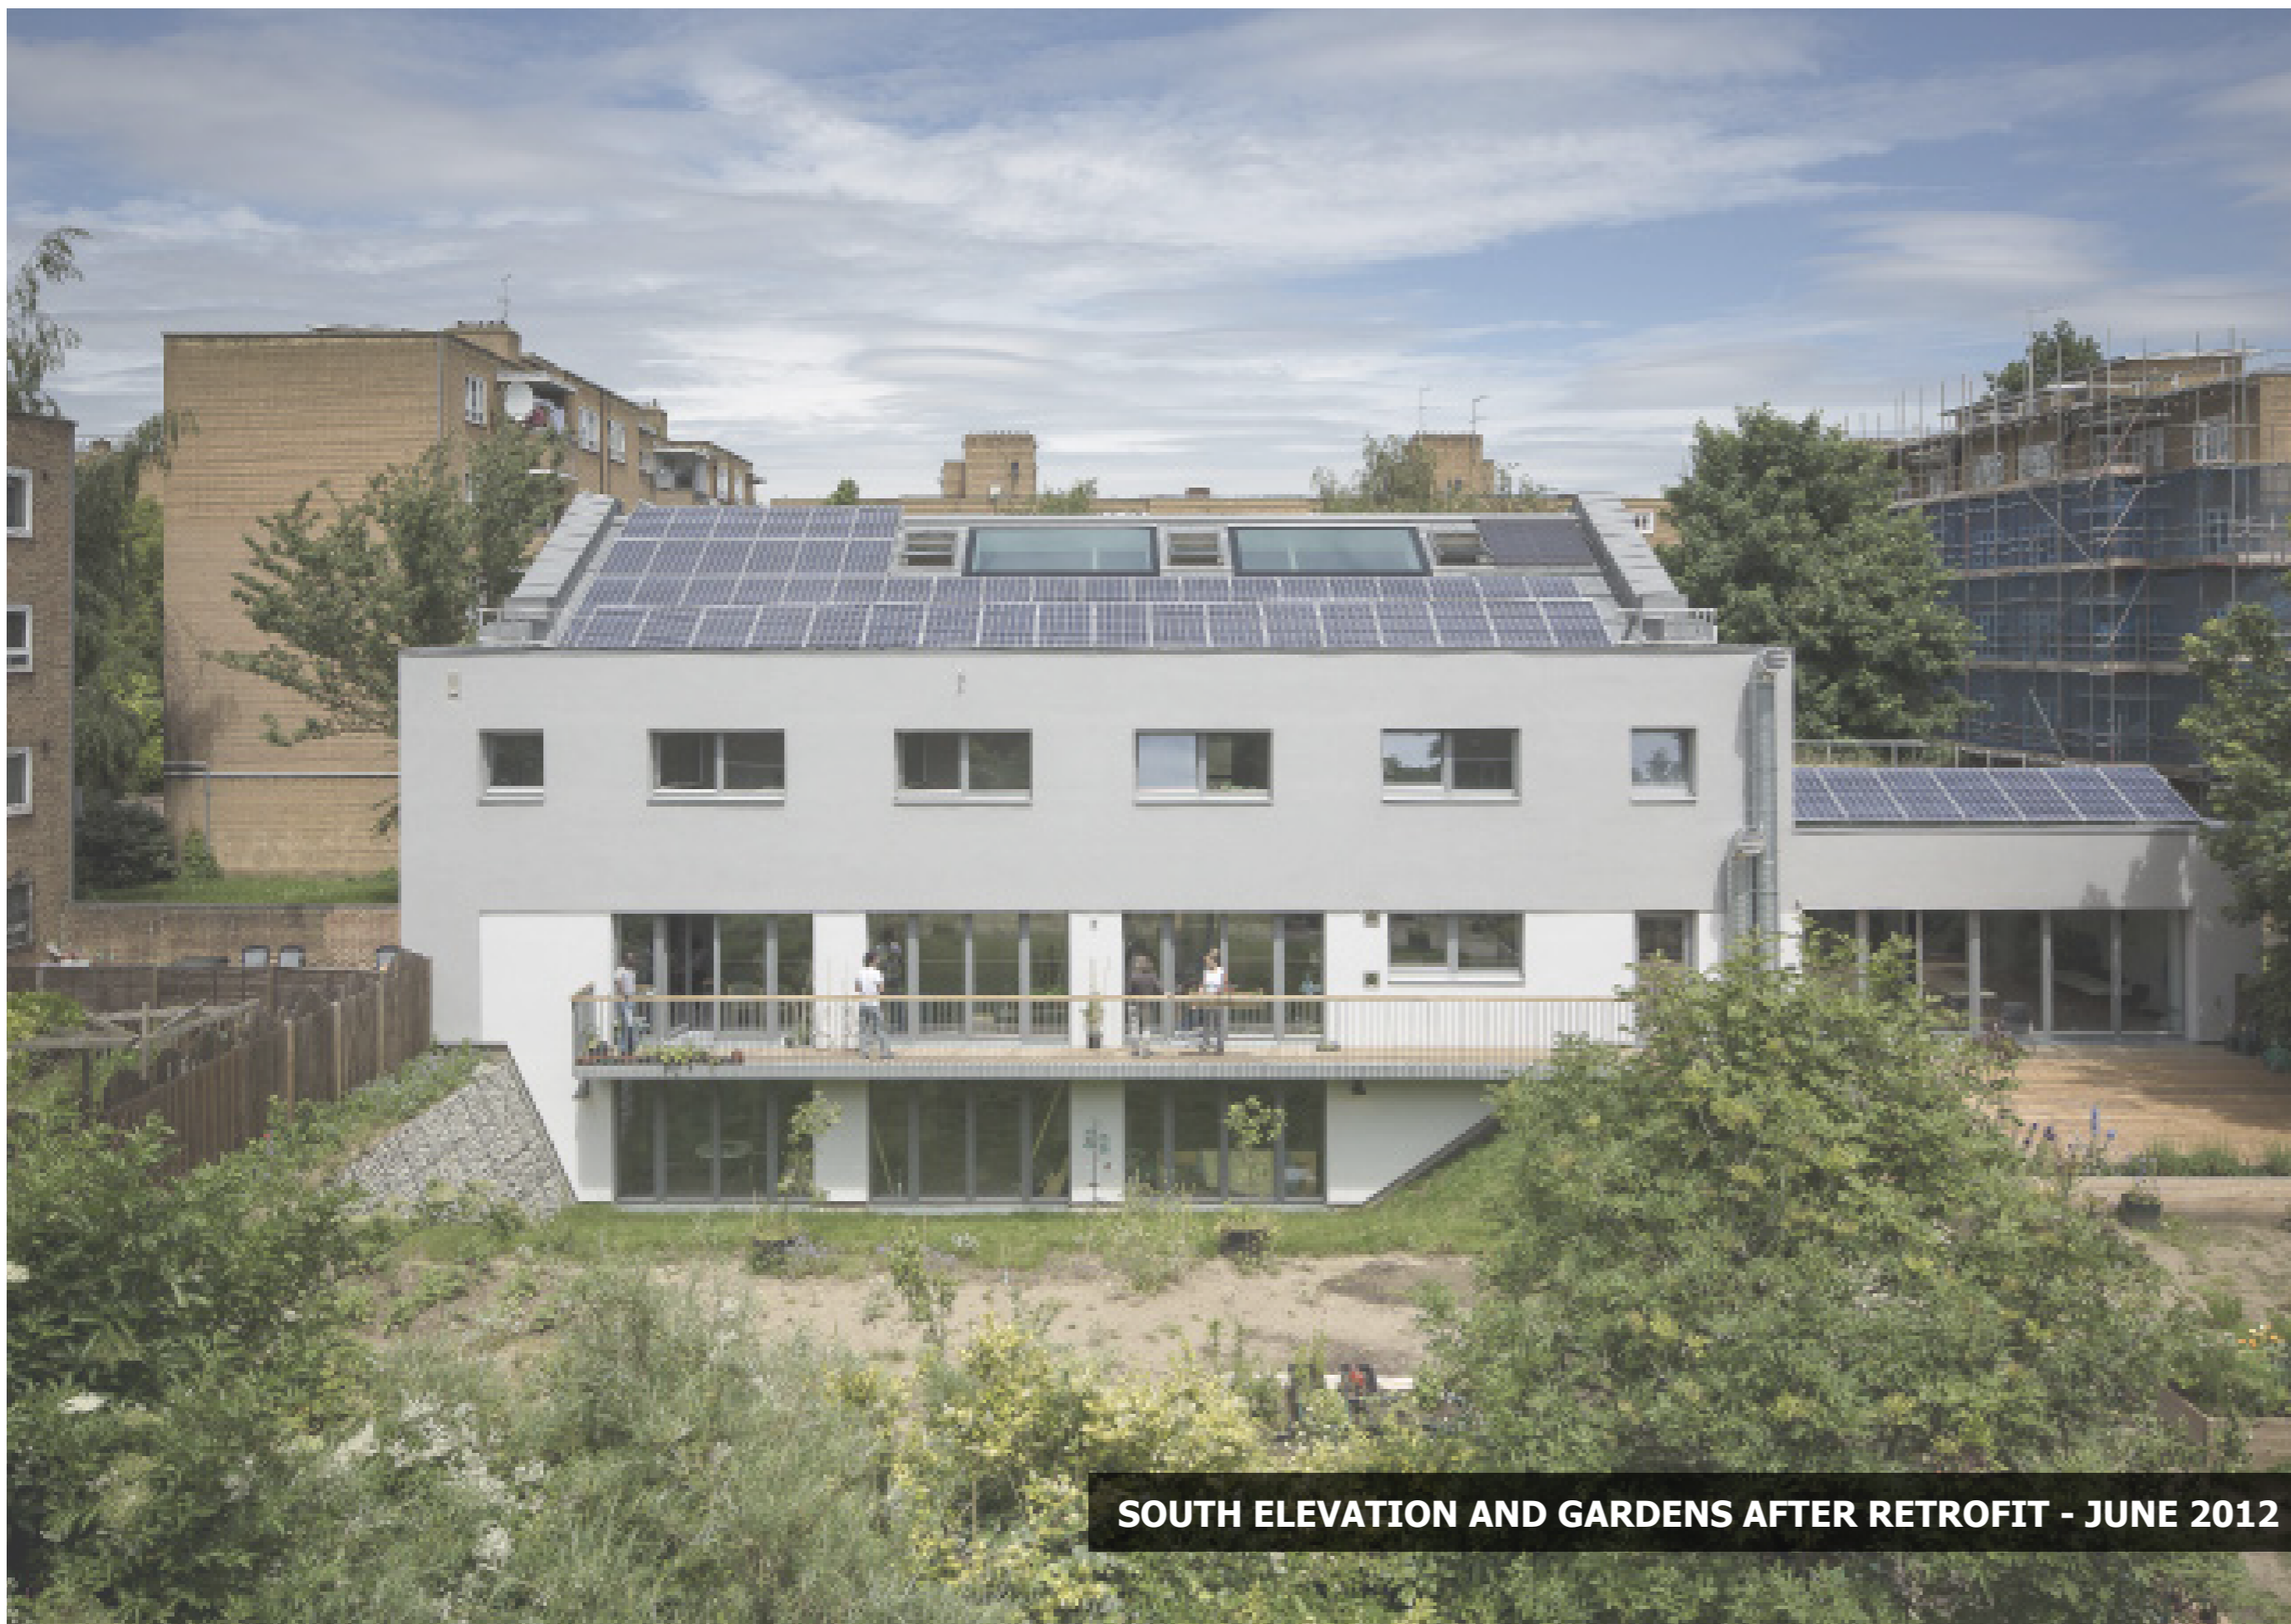
SOUTH ELEVATION AND GARDENS AFTER RETROFIT - JUNE 2012

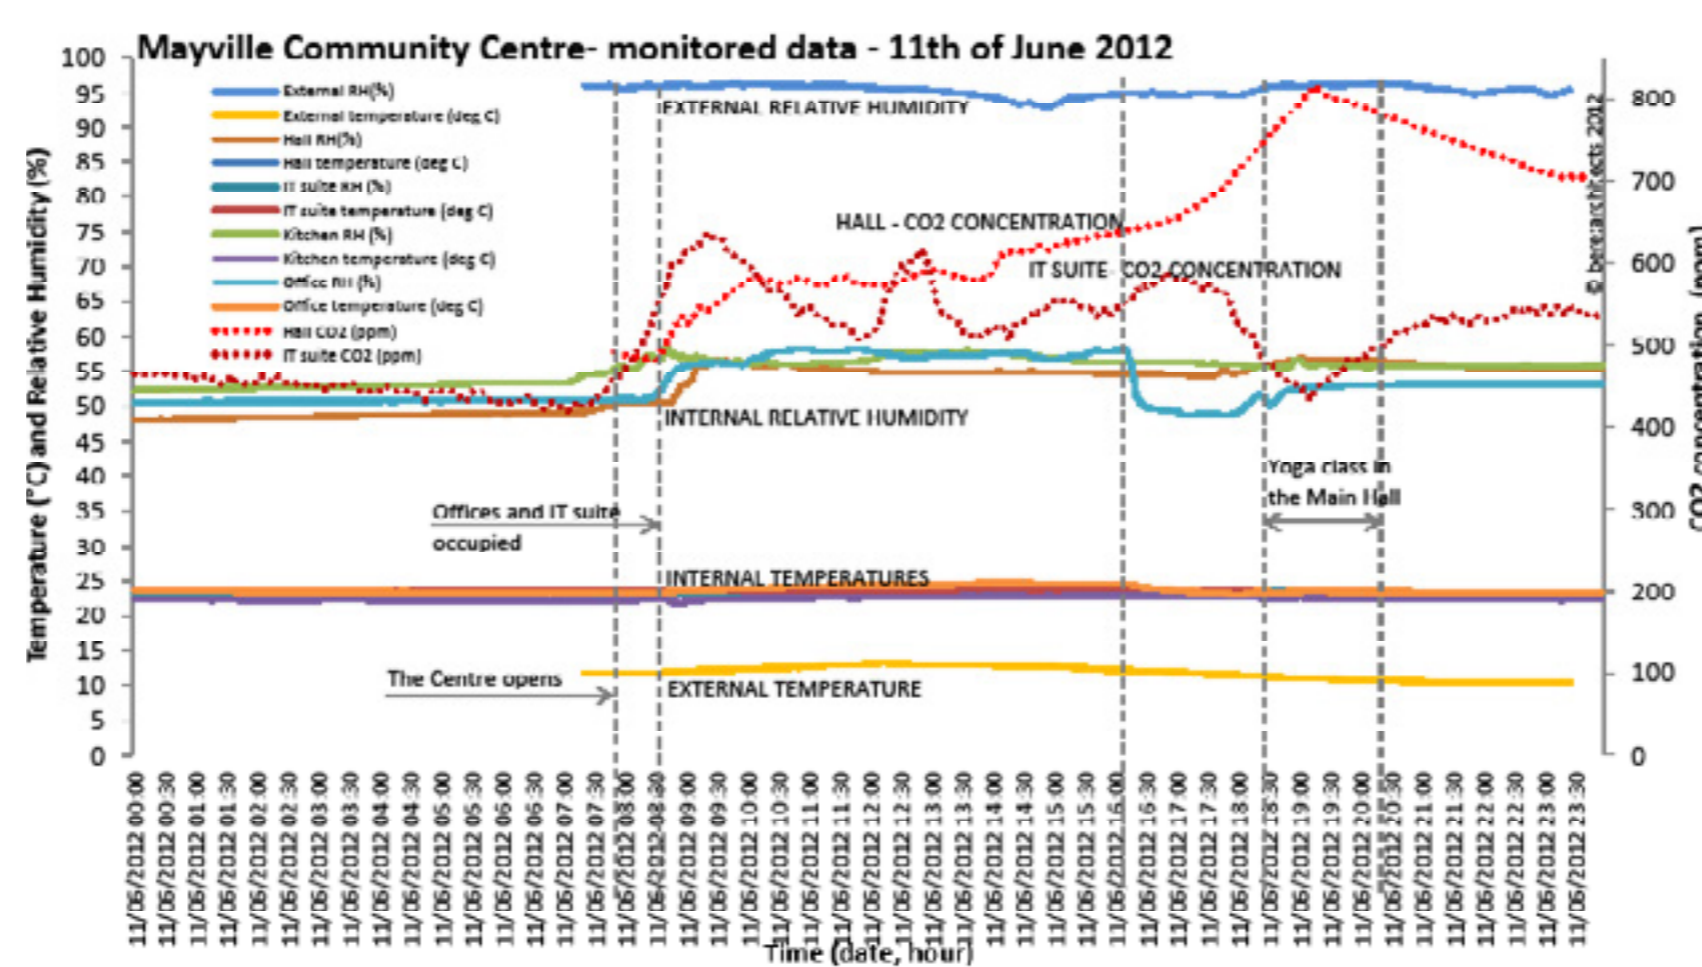
ENVIRONMENTAL PERFORMANCE - TYPICAL DAY JUNE

Primary Energy Demand: 120kWh/(m²a)
 Heating Load: 11W/m² Cooling Load: 8W/m²
 Heating and Cooling Demand: 13kWh/(m²a)
 Ventilation strategy winter: Supply to offices and main hall, extract from main hall (high level), kitchen and bathrooms. CO₂ sensors in hall open motorized dampers, increasing supply from constant pressure Paul Maxi 2000.
 Ventilation strategy summer: Background supply to offices in daytime, high level tilt windows and secure ventilation grills for natural night time purge cooling.
